Damage to facilities, etc. including on-site
survey by the Great East Japan
Earthquake
-Consequences of the tsunami -

Koichi FUJITA

River Department, NILIM, MLIT, Japan

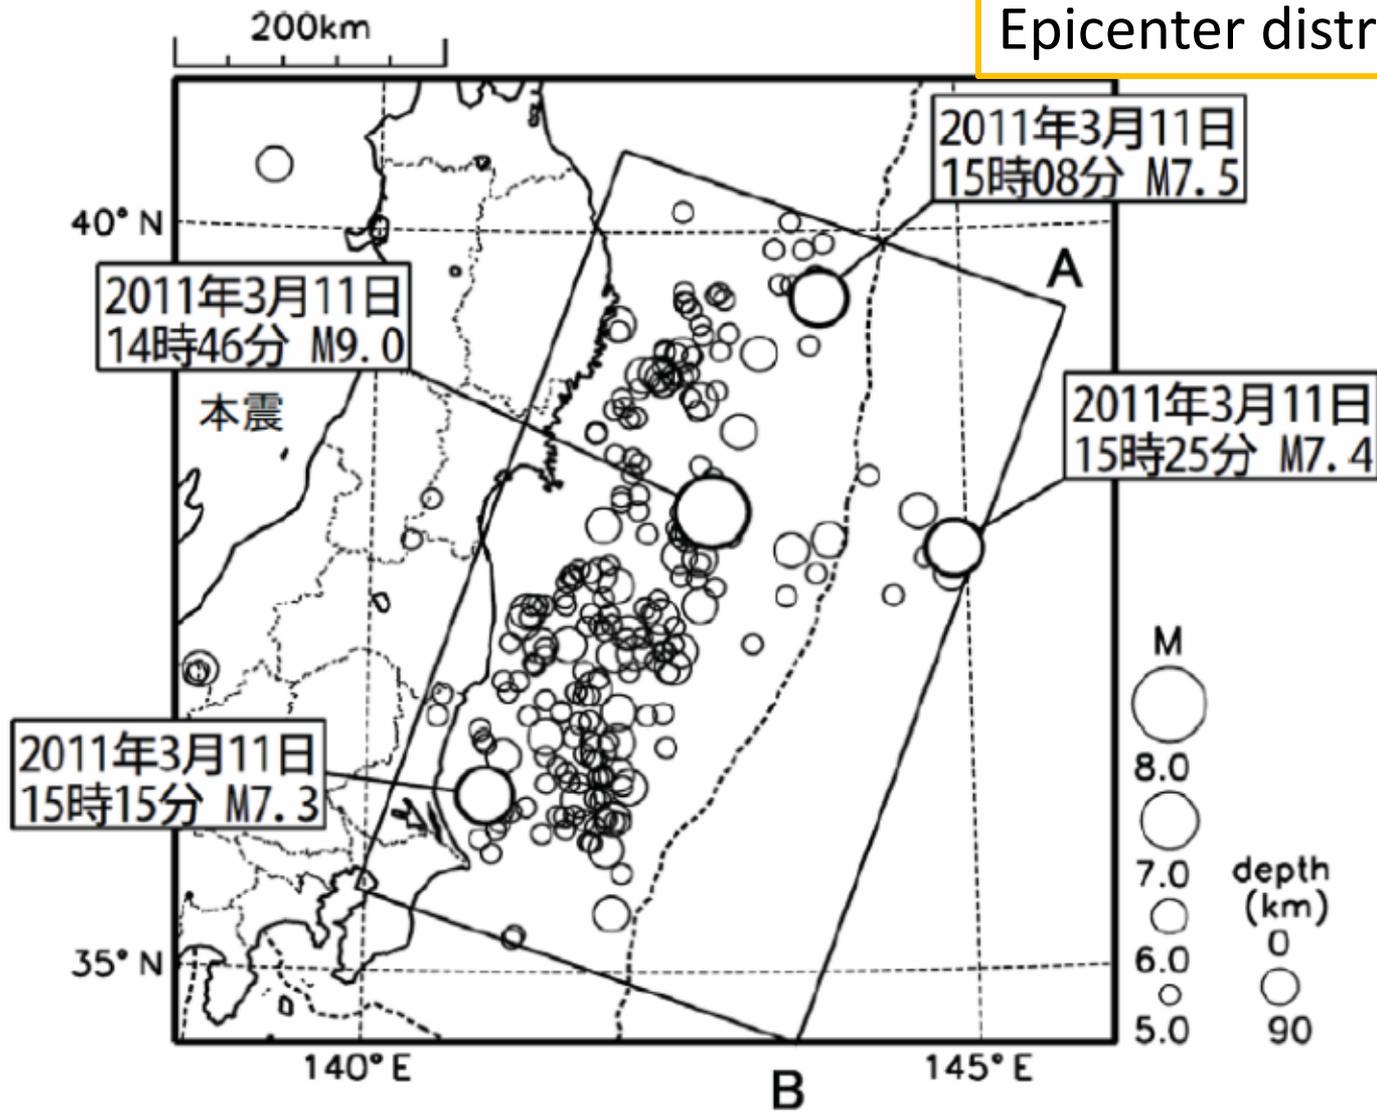
震央分布図 (本震以外は速報値)

Epicenter distribution

丸の大きさはマグニチュードの大きさを表す。

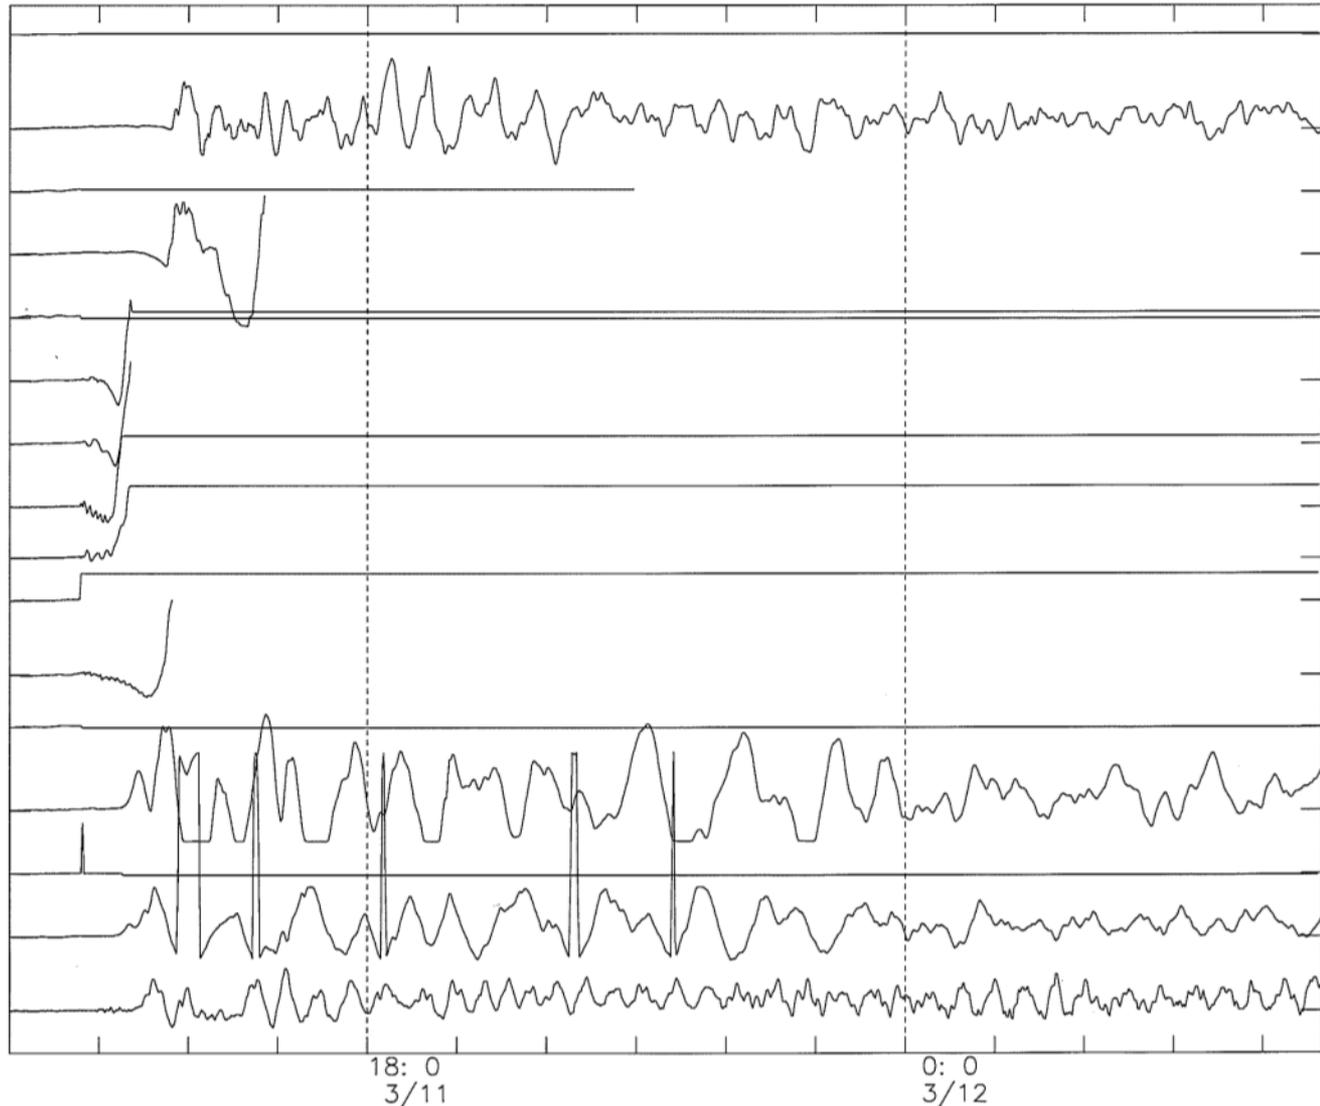
Tide levels observed along the Pacific coast of the Tohoku Region

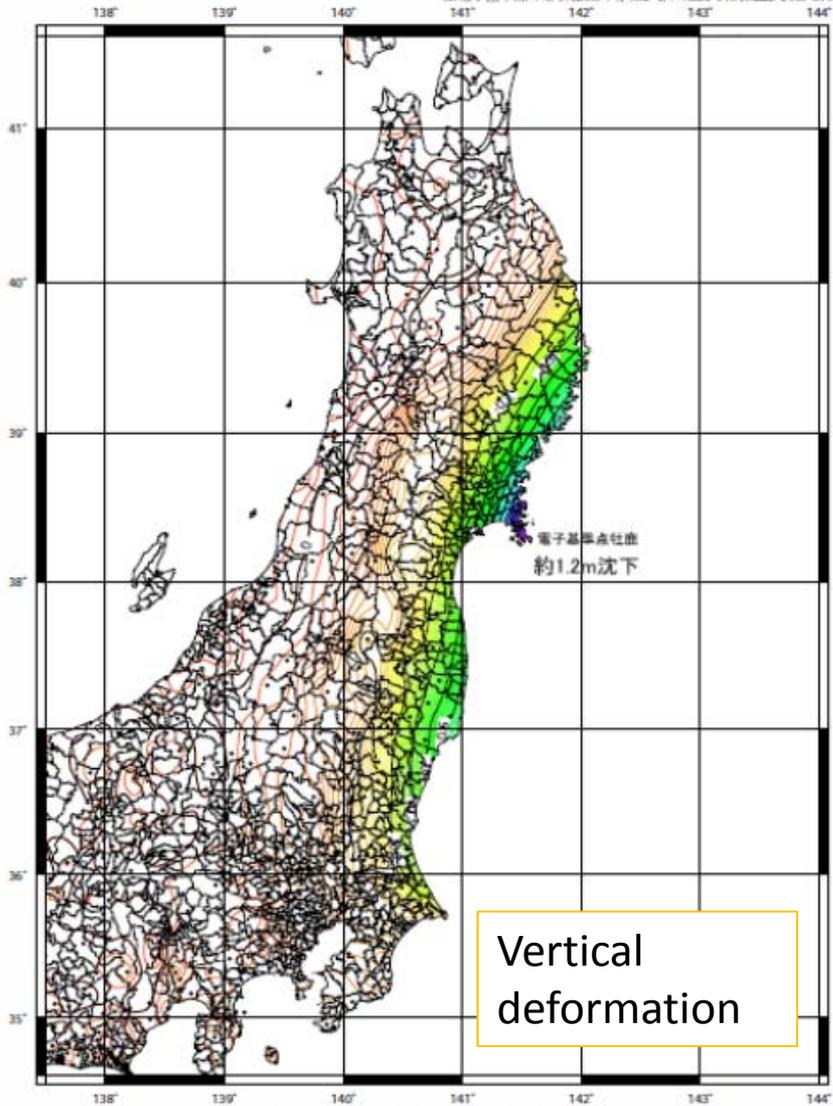
R3-Q3 等変動量線図 (上下 ΔU)

Vertical deformation

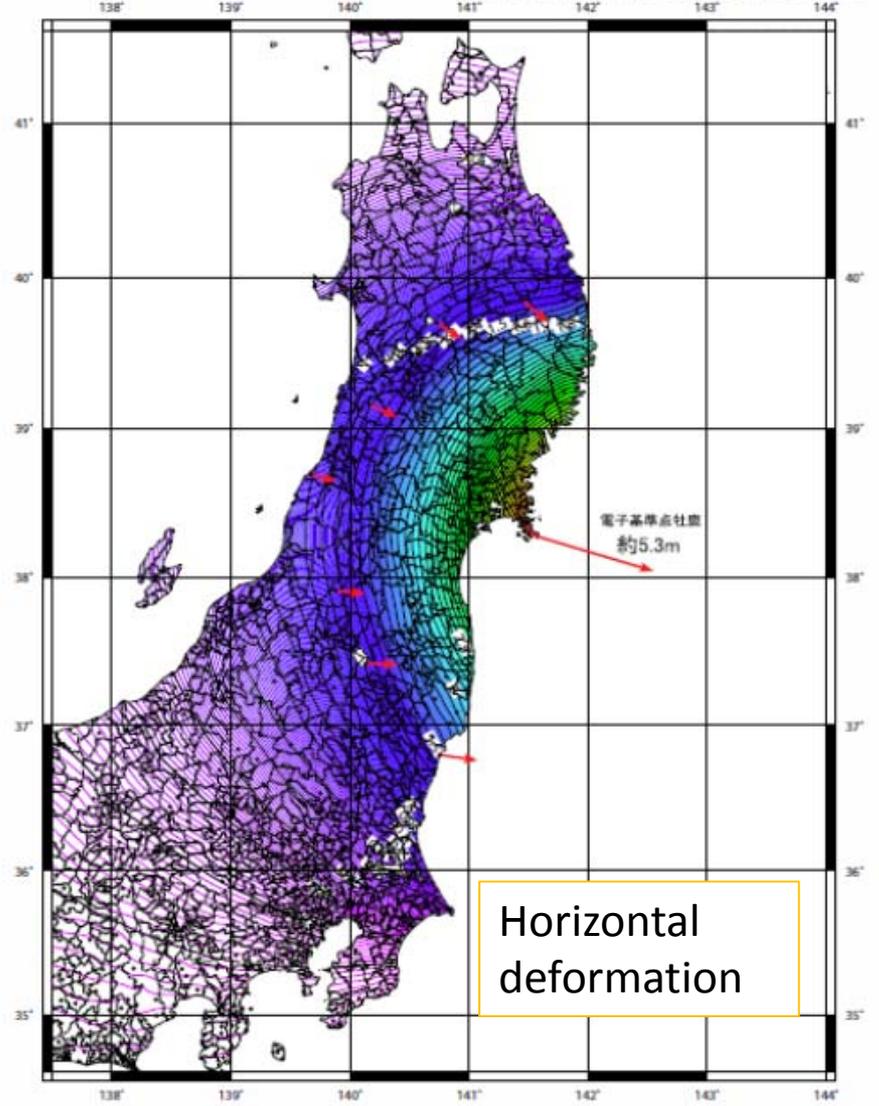
R3-Q3 等変動量線図 (水平変動量 ΔS)

Horizontal deformation

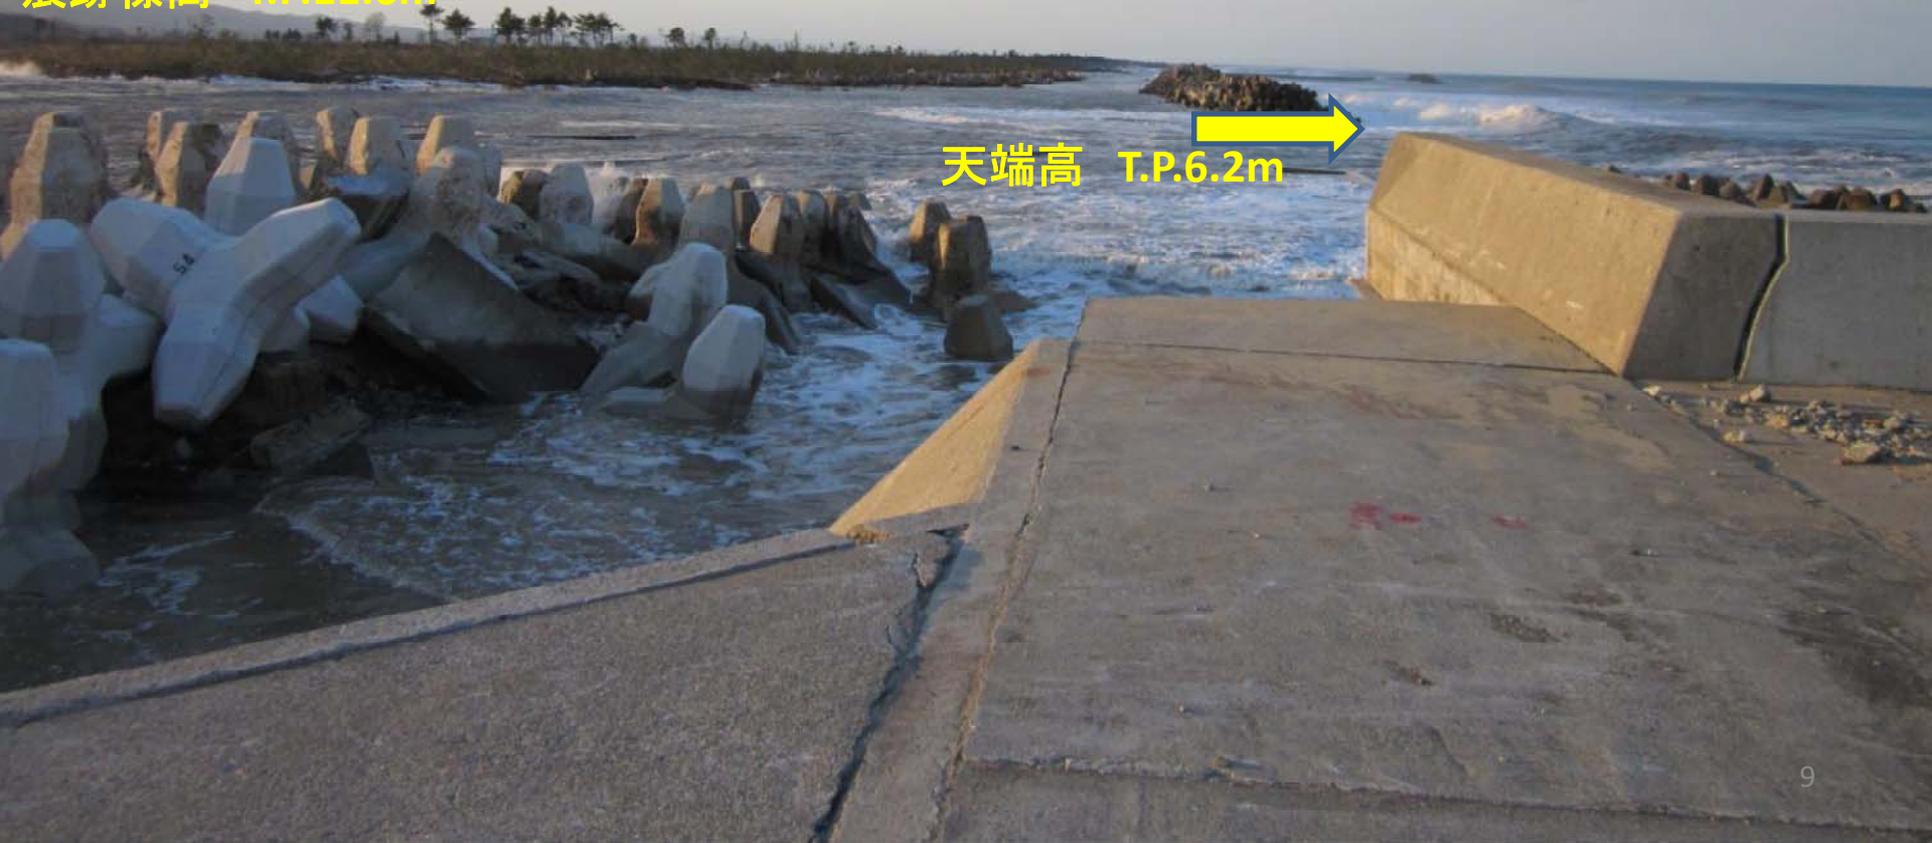
痕跡標高 T.P.11.6m

天端高 T.P.6.2m

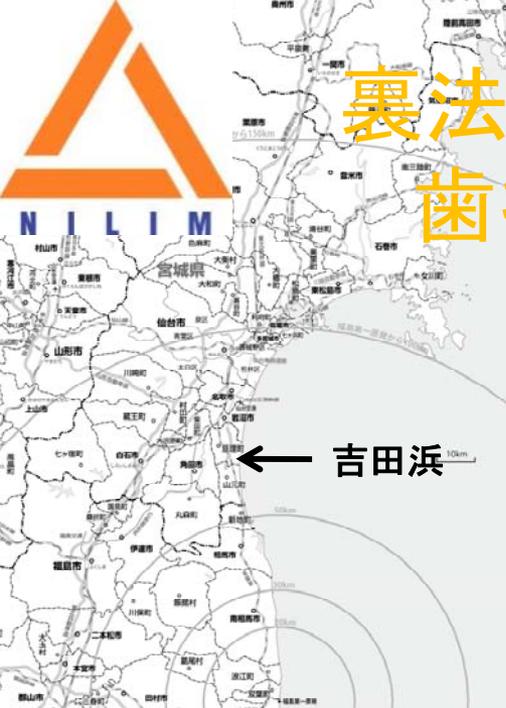
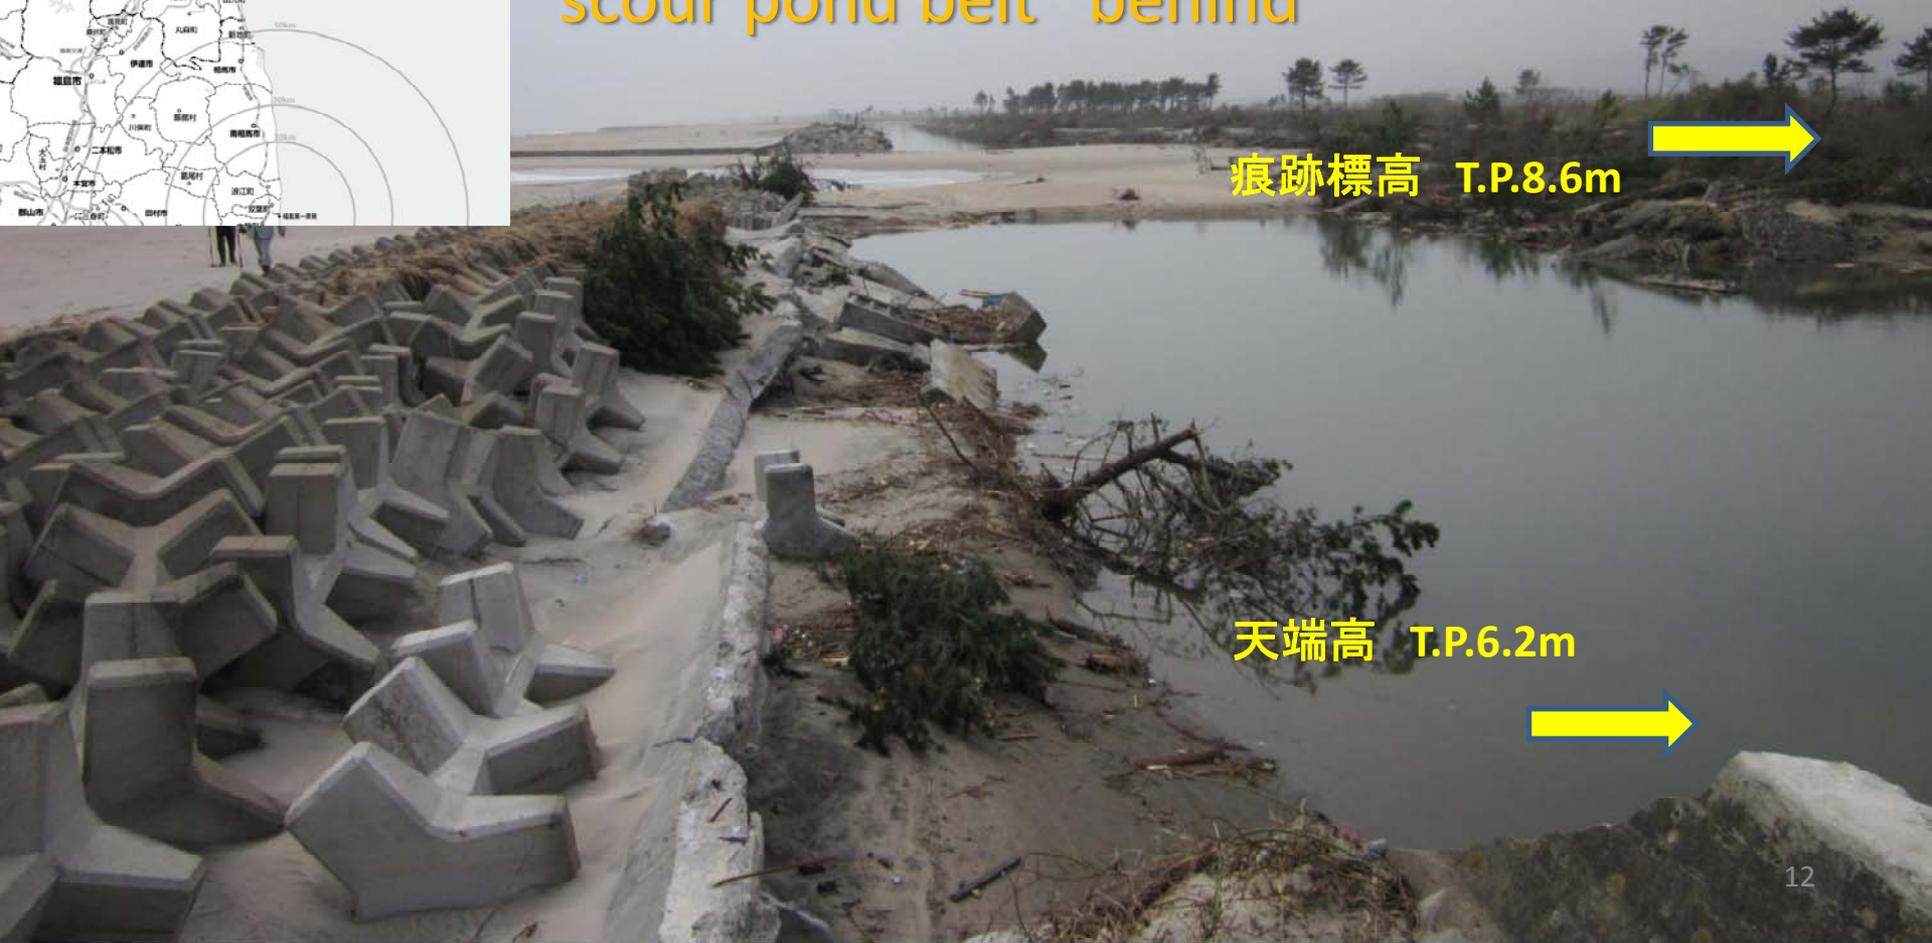
裏法尻洗掘・裏法侵食を伴う堤防半壊 歯抜け状に発生している全壊箇所 (吉田浜)

Total dyke collapse accompanied by
“scour pond belt” behind

痕跡標高 T.P.8.6m

天端高 T.P.6.2m

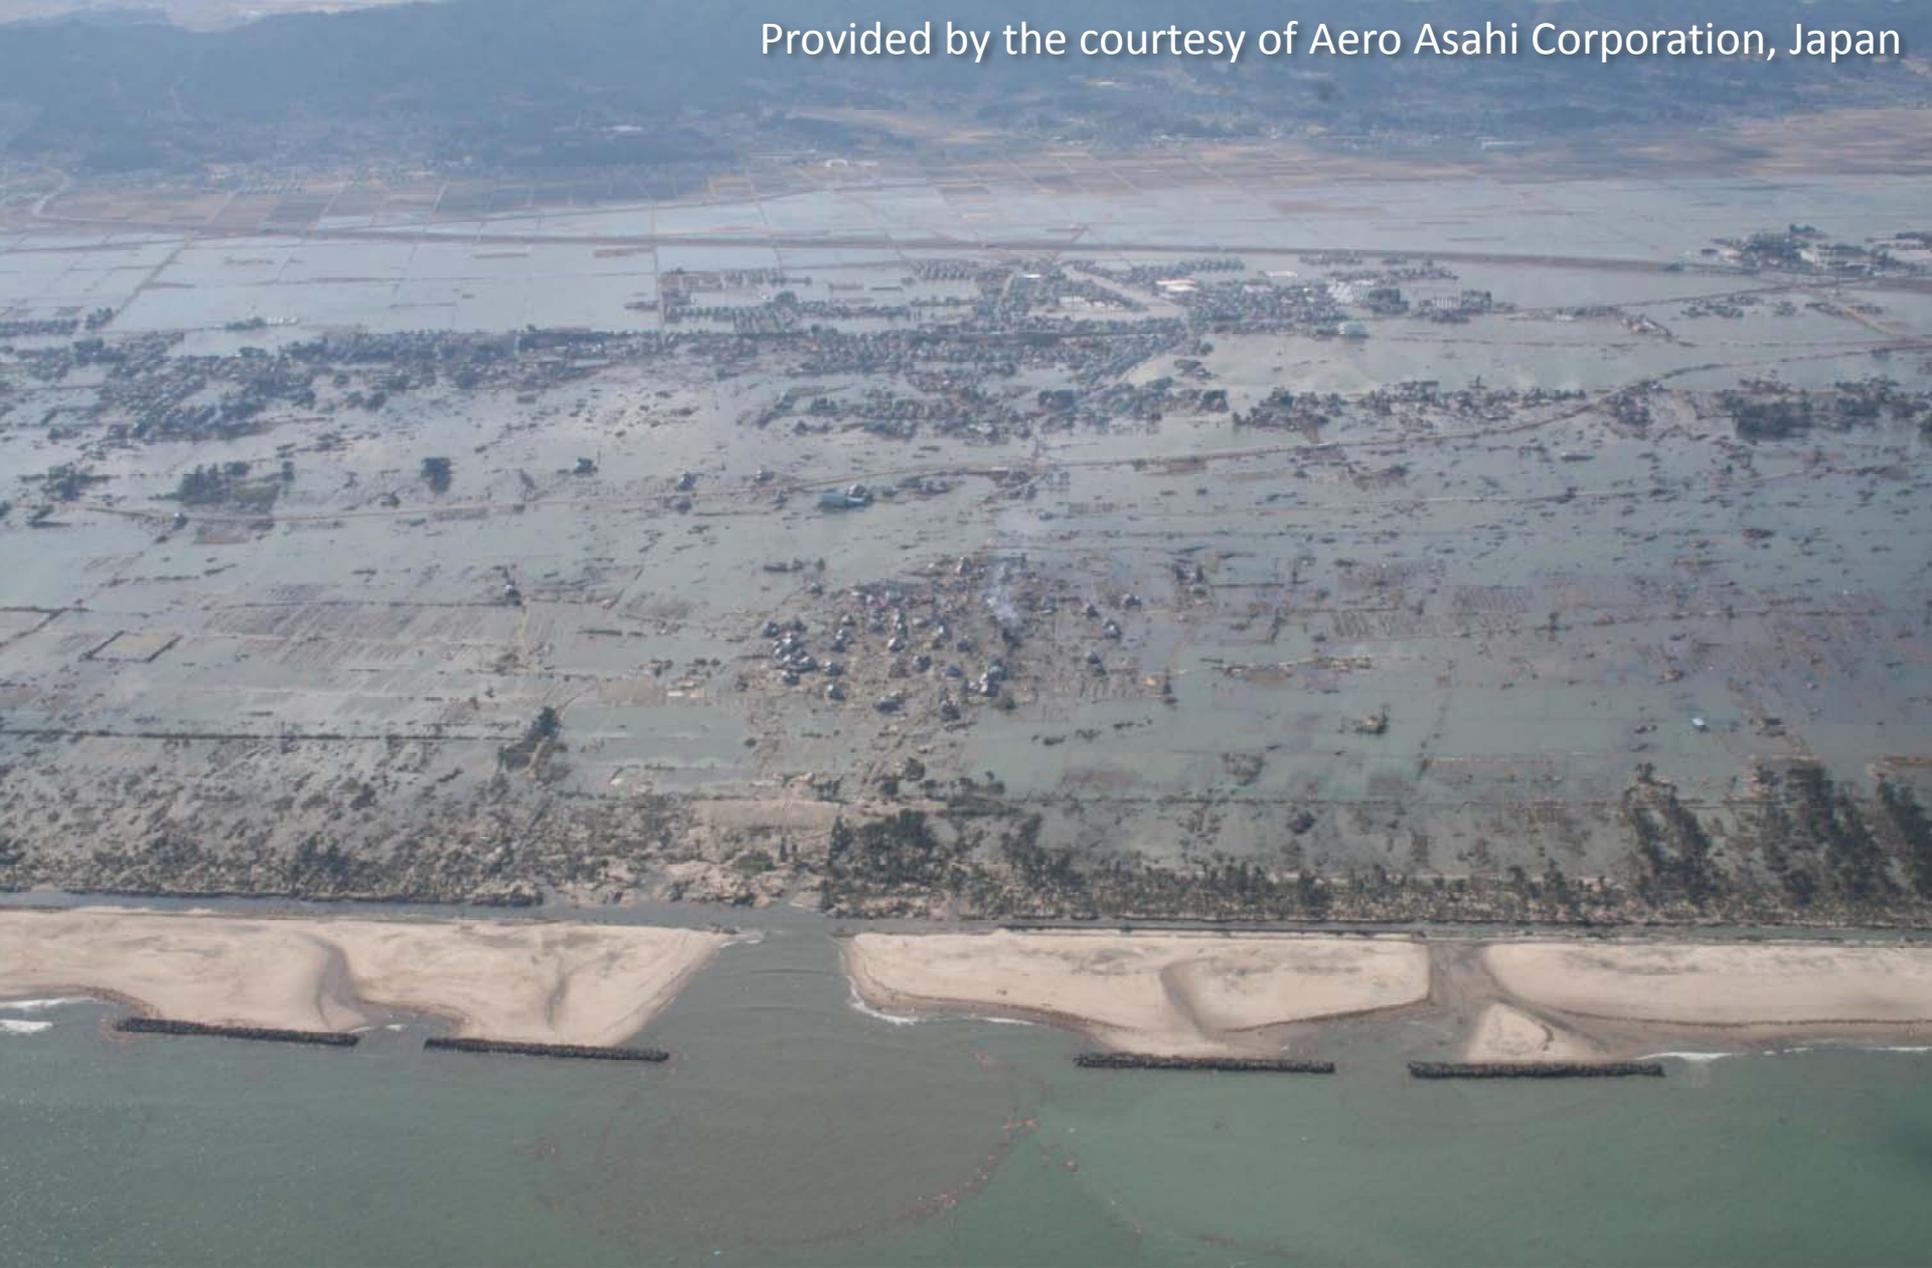
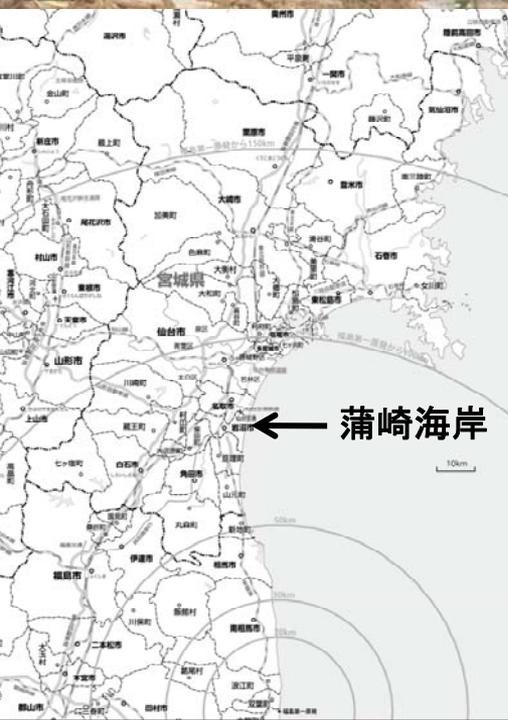
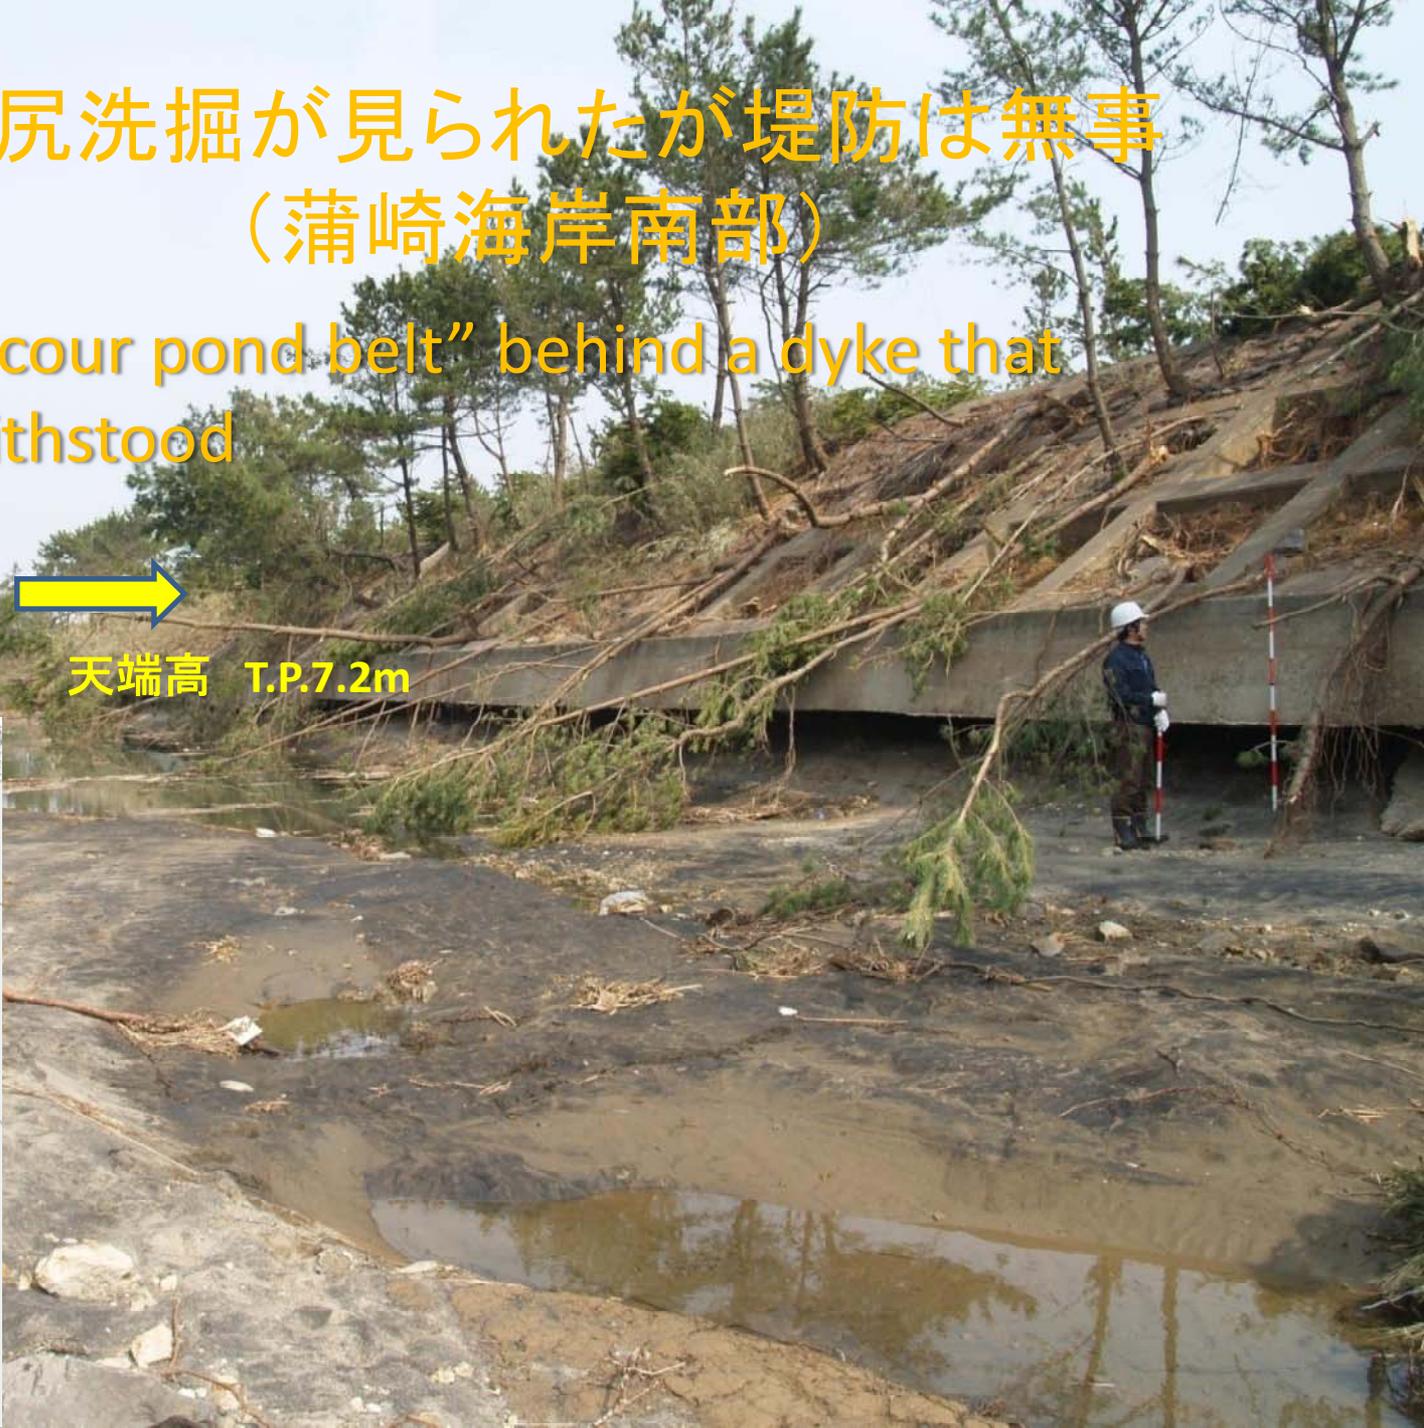
法尻洗掘が見られたが堤防は無事 (蒲崎海岸南部)

“Scour pond belt” behind a dyke that withstood

← 痕跡標高 T.P.7.6m

→ 天端高 T.P.7.2m

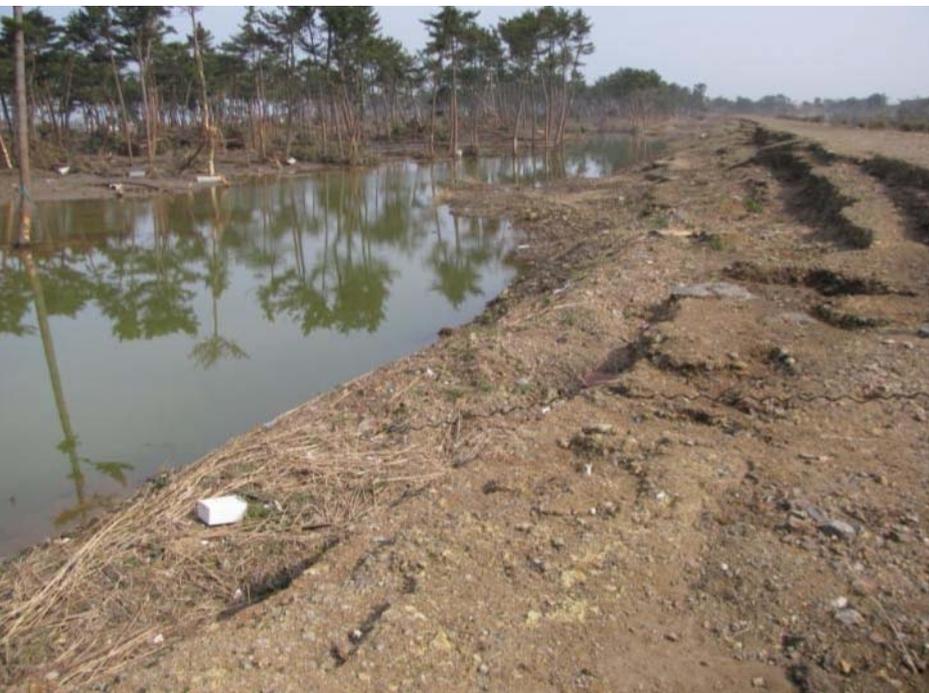
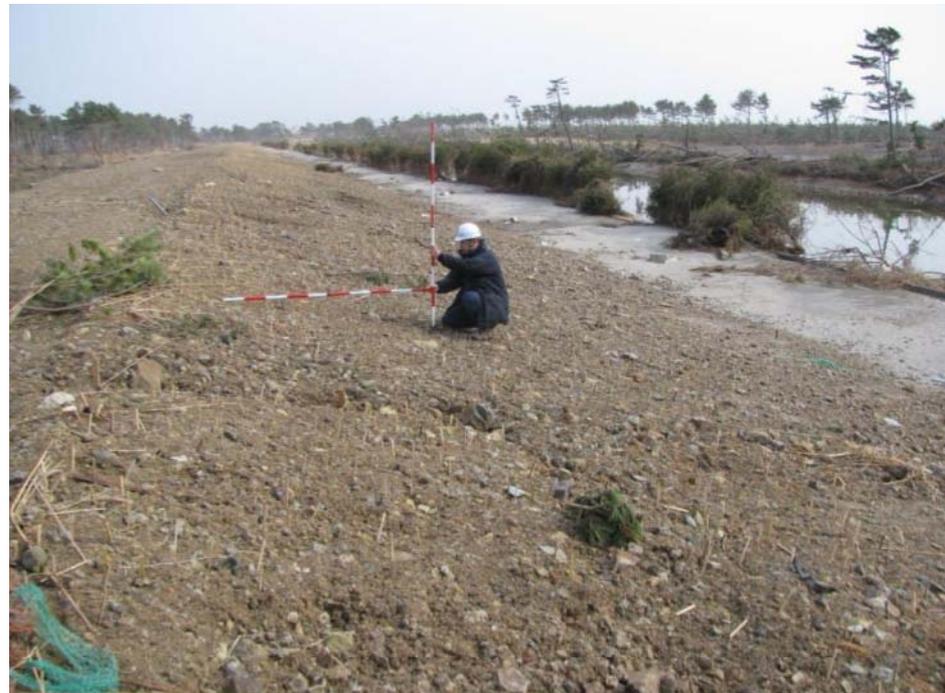
Combination of a severely damaged backside and a slightly damaged sea side was frequently observed for a trapezoidal dyke.

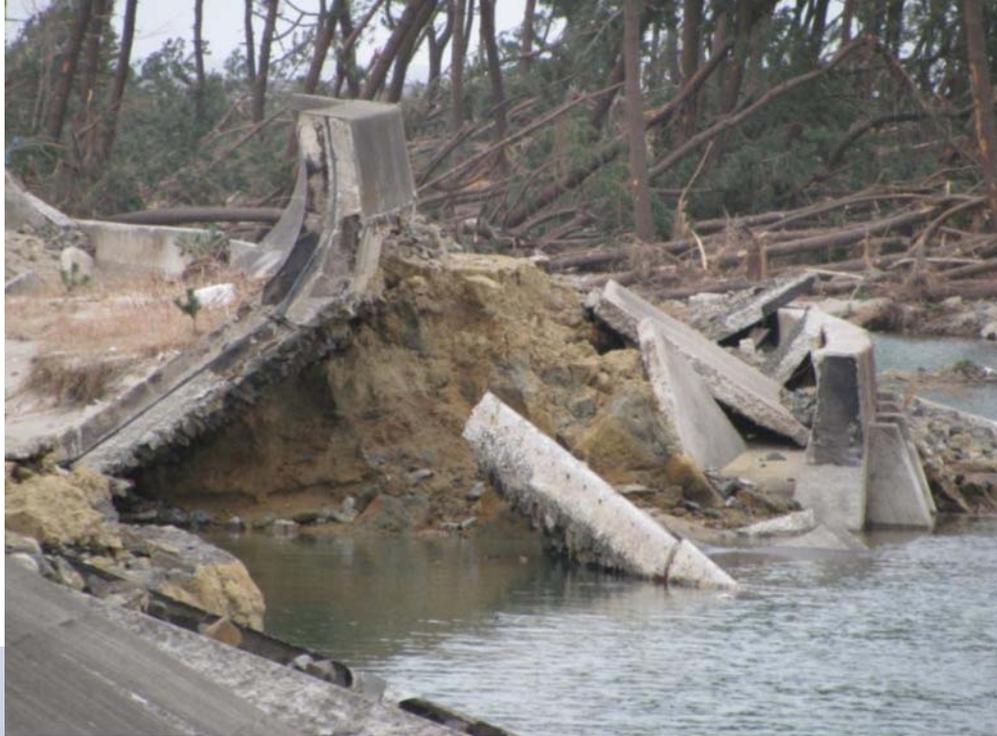
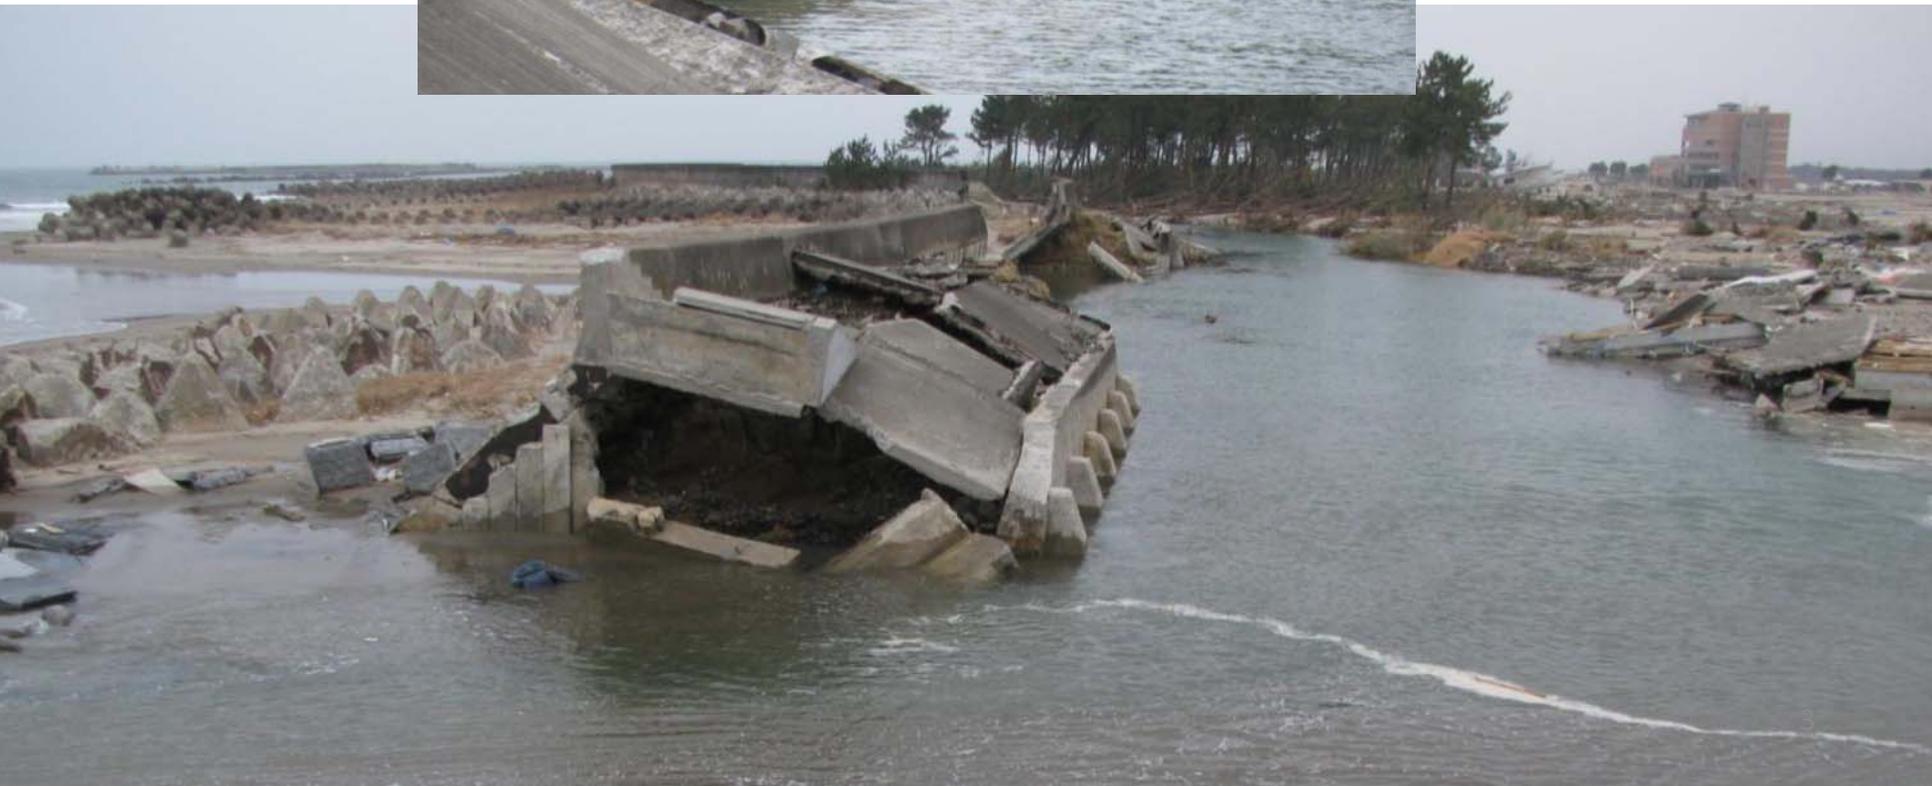
Connection between a coastal dyke and a river dyke

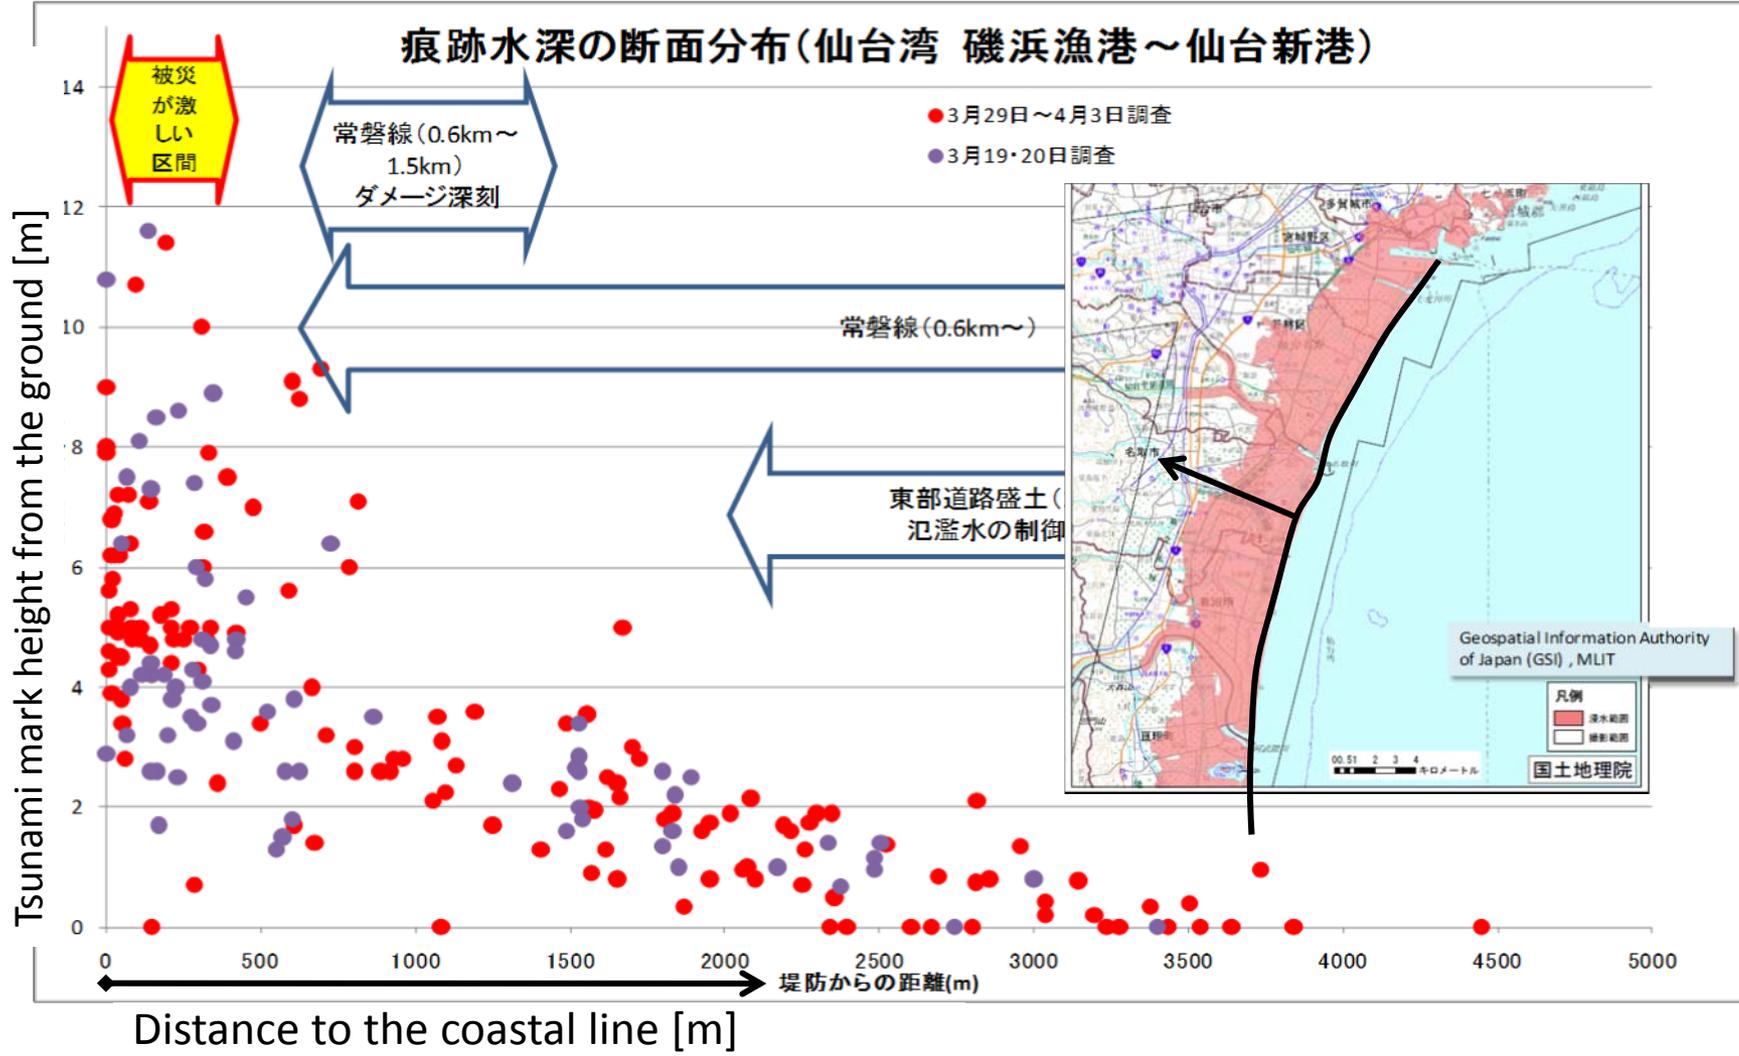
Maximum water depth estimated from tsunami marks in the Sendai Plain in relation to a distance to the coastal line (By NILIM)

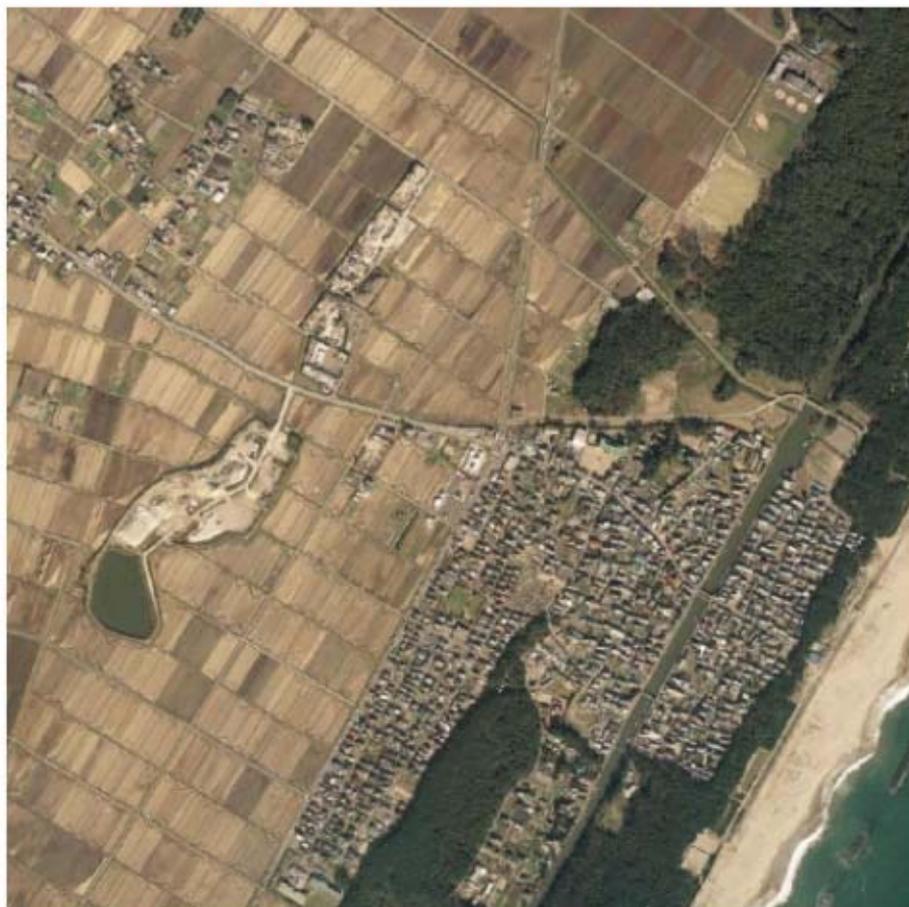
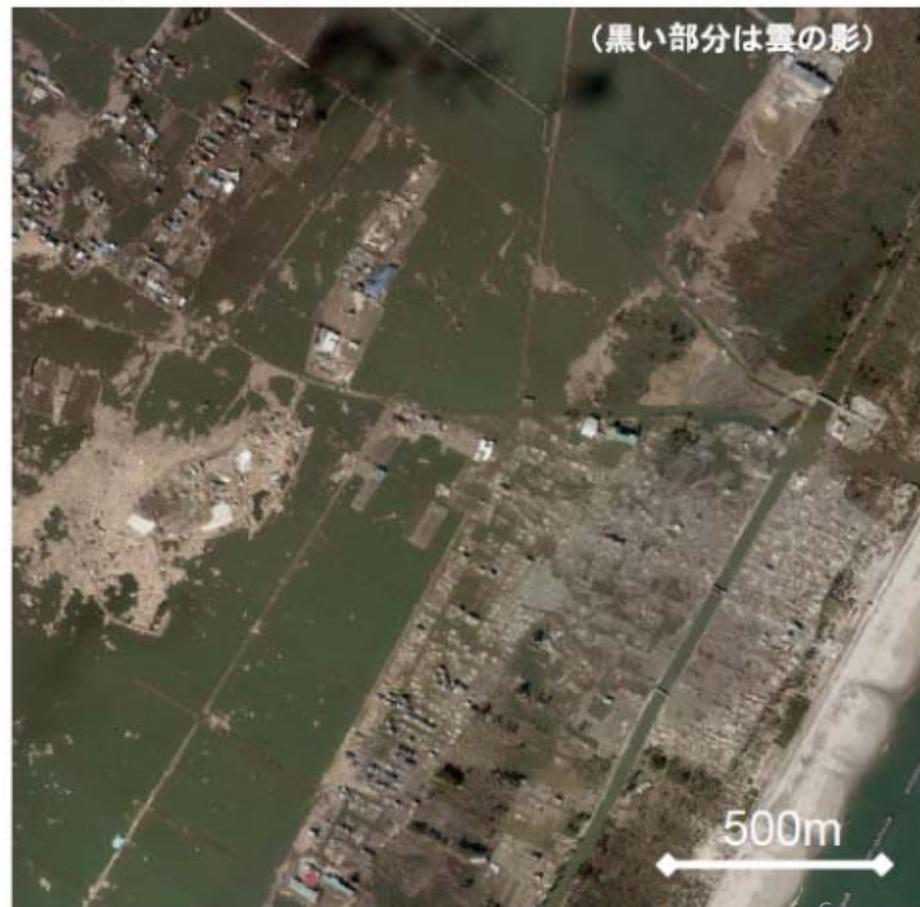
仙台市若林区荒浜周辺の被災状況 (新旧画像)

被災前(平成18年10月撮影)

被災後(平成23年3月12日撮影)

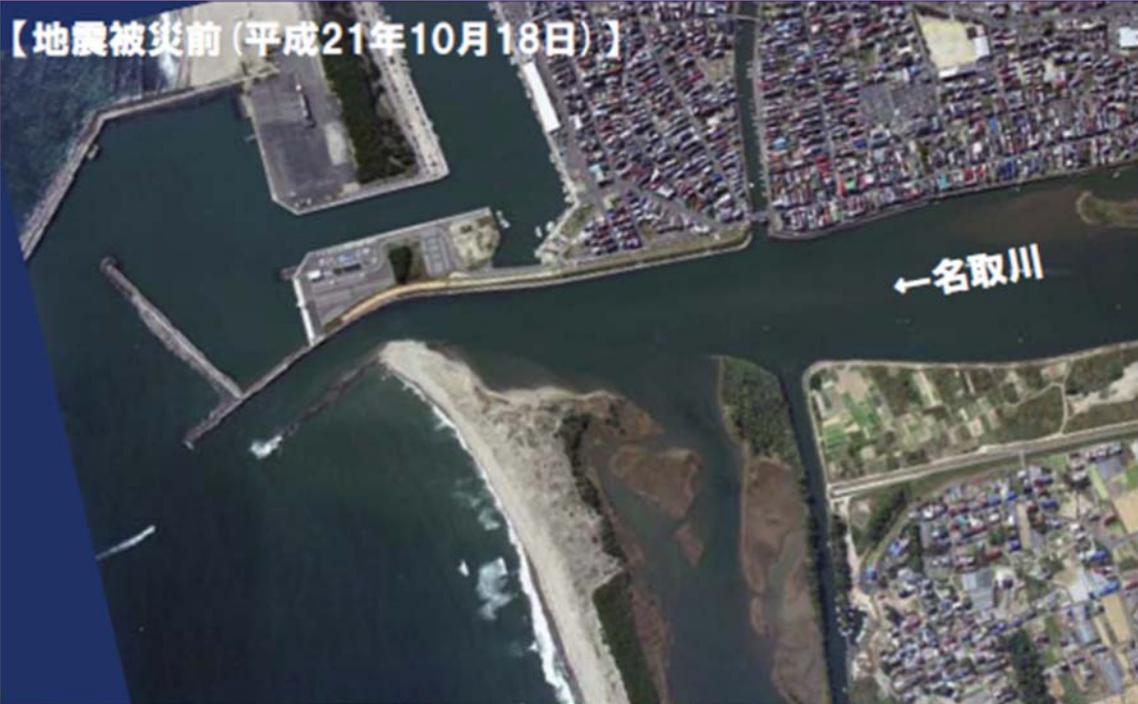
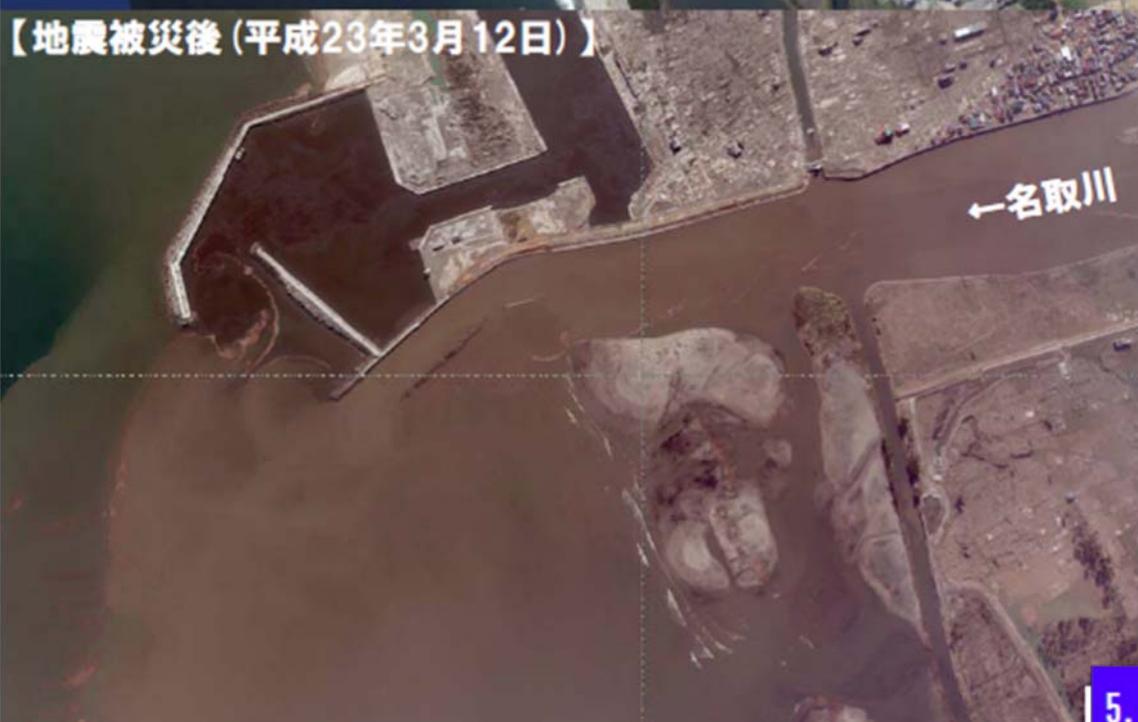
【地震被災前(平成21年10月18日)】

【地震被災後(平成23年3月12日)】
