Damage to facilities, etc. including on-site
survey by the Great East Japan
Earthquake
-Consequences of the tsunami -

Koichi FUJITA

River Department, NILIM, MLIT, Japan

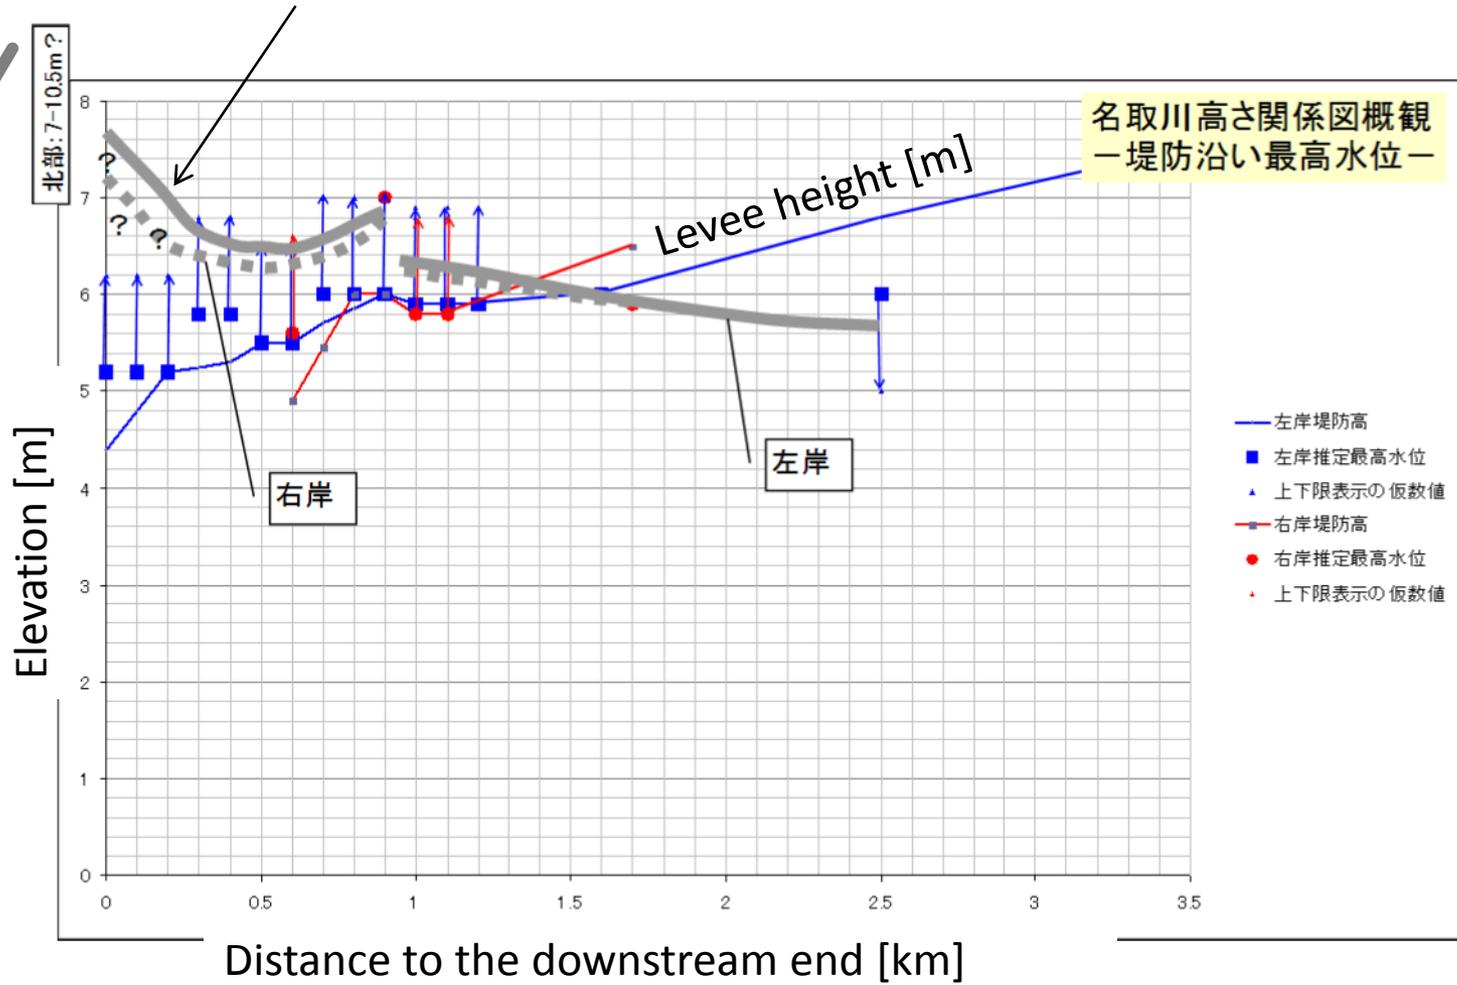
Possible longitudinal profiles of highest water levels along the Natori River

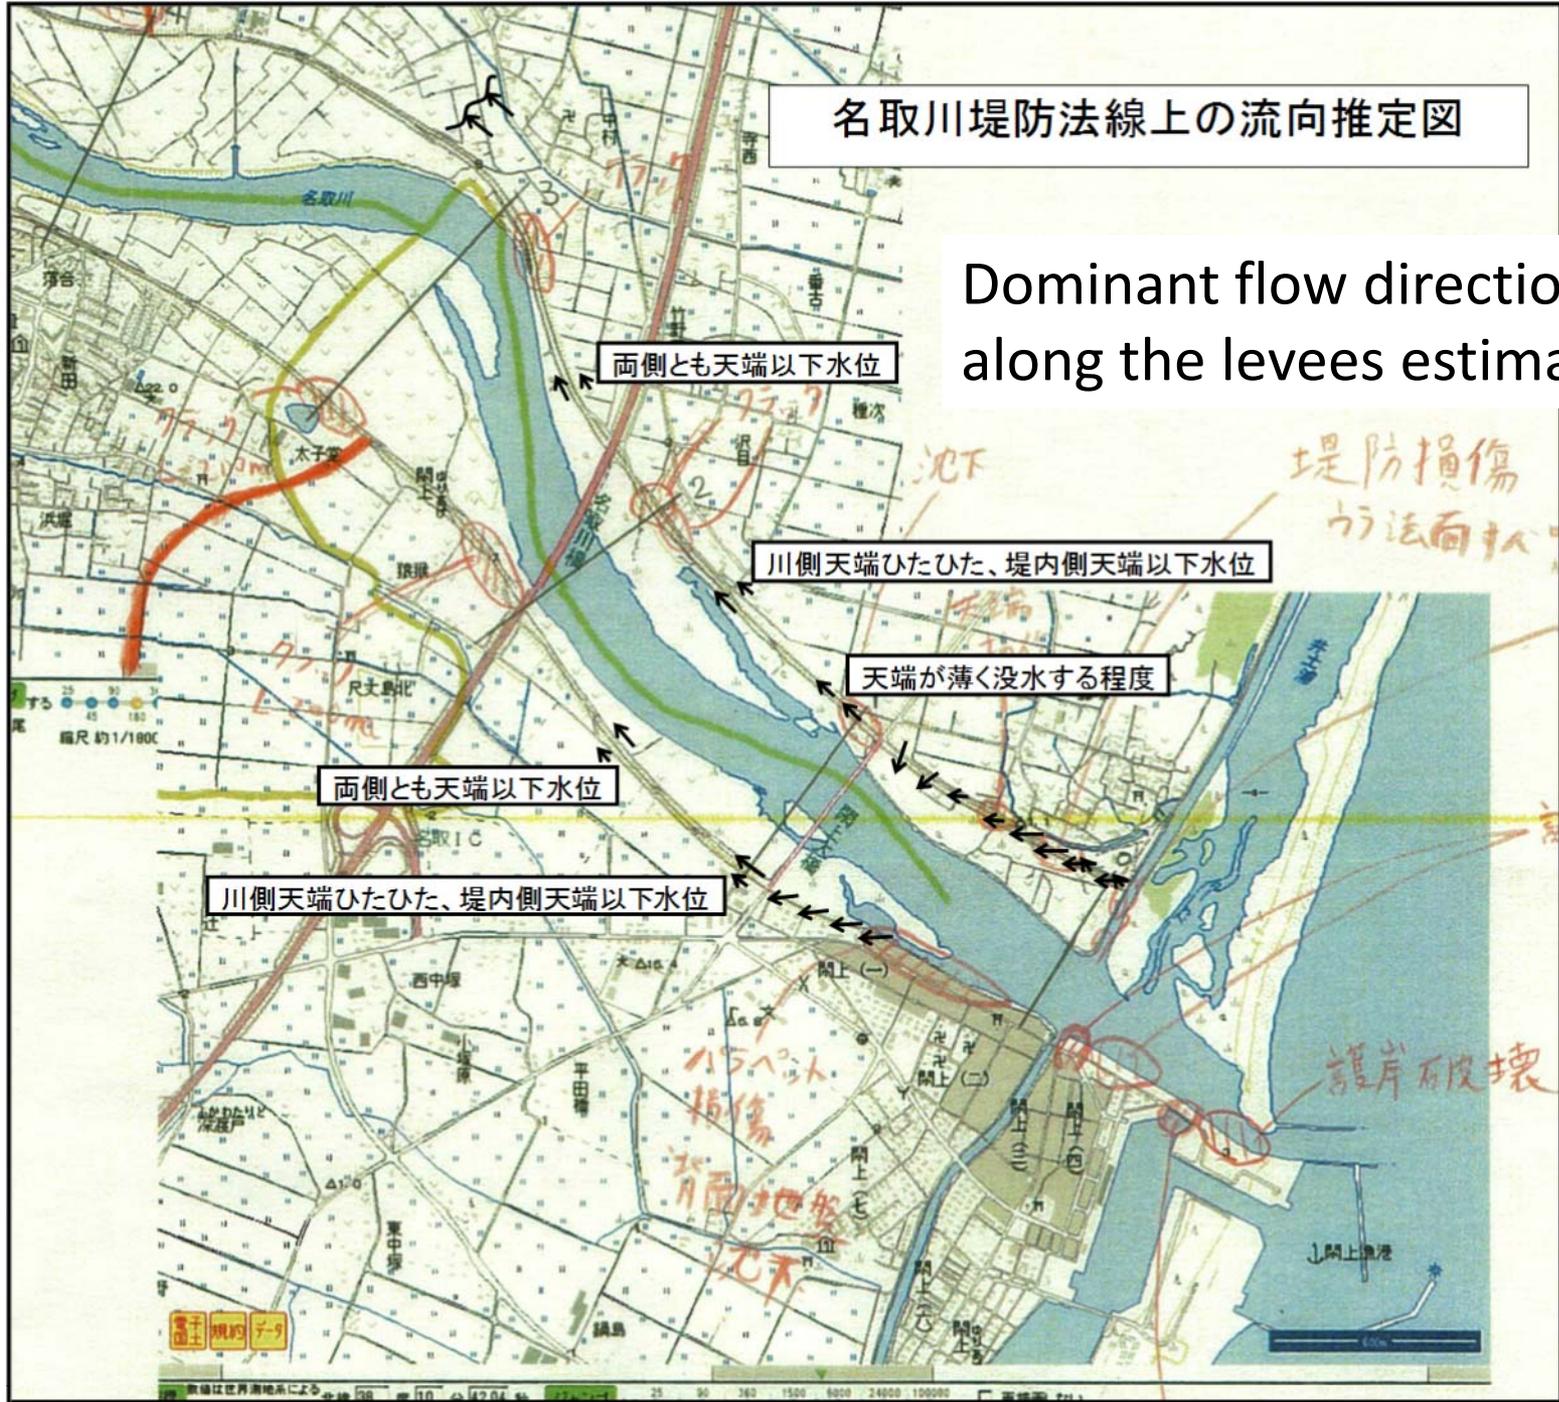
名取川堤防法線上の流向推定図

Dominant flow direction along the levees estimated

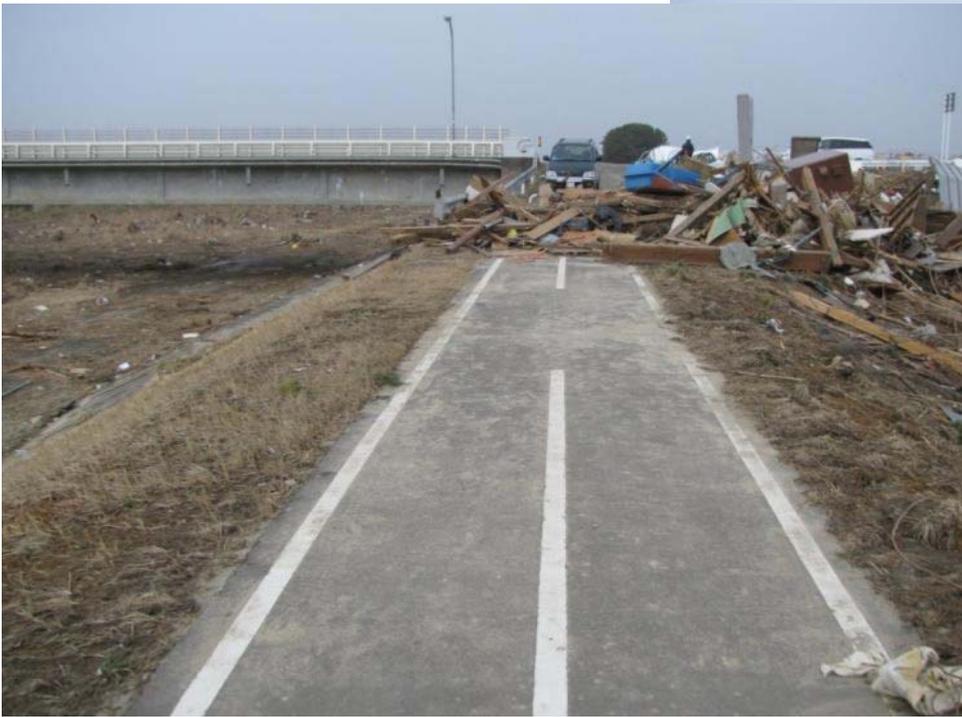
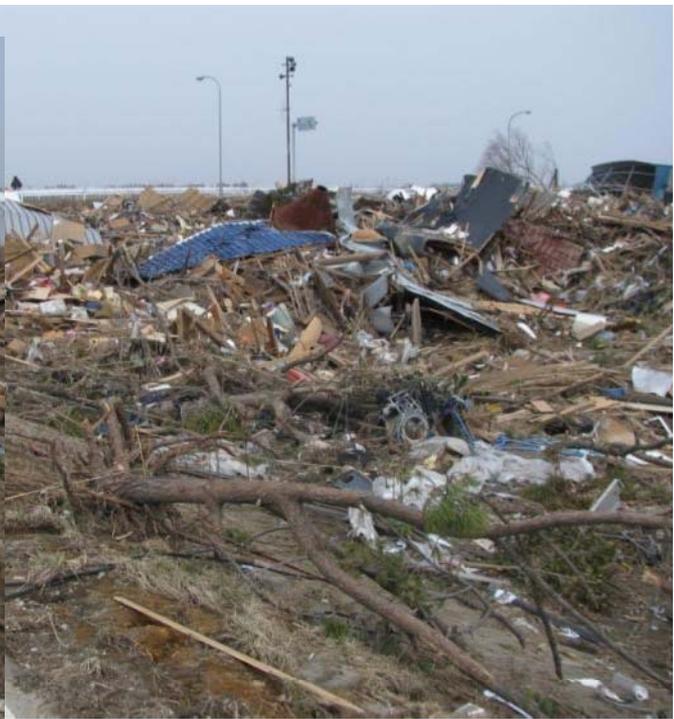
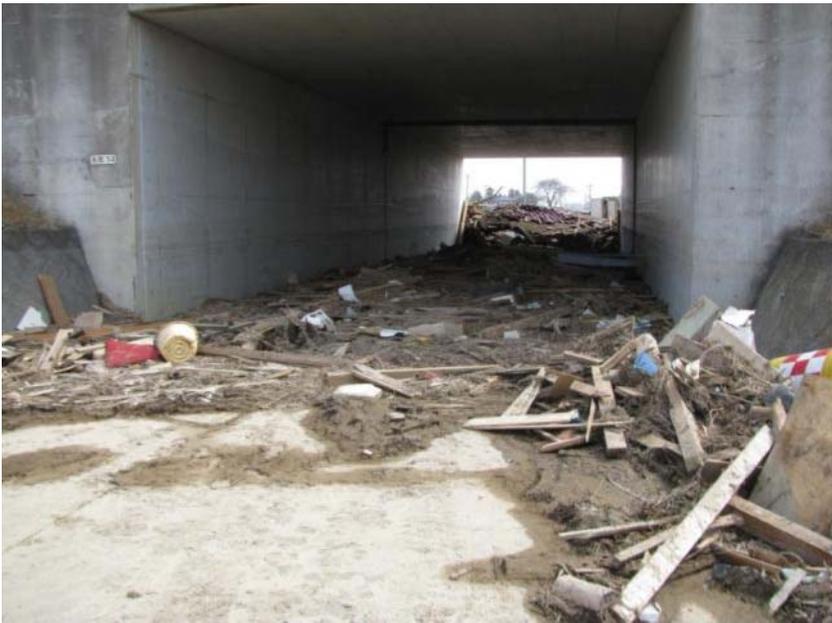
Role of a road embankment

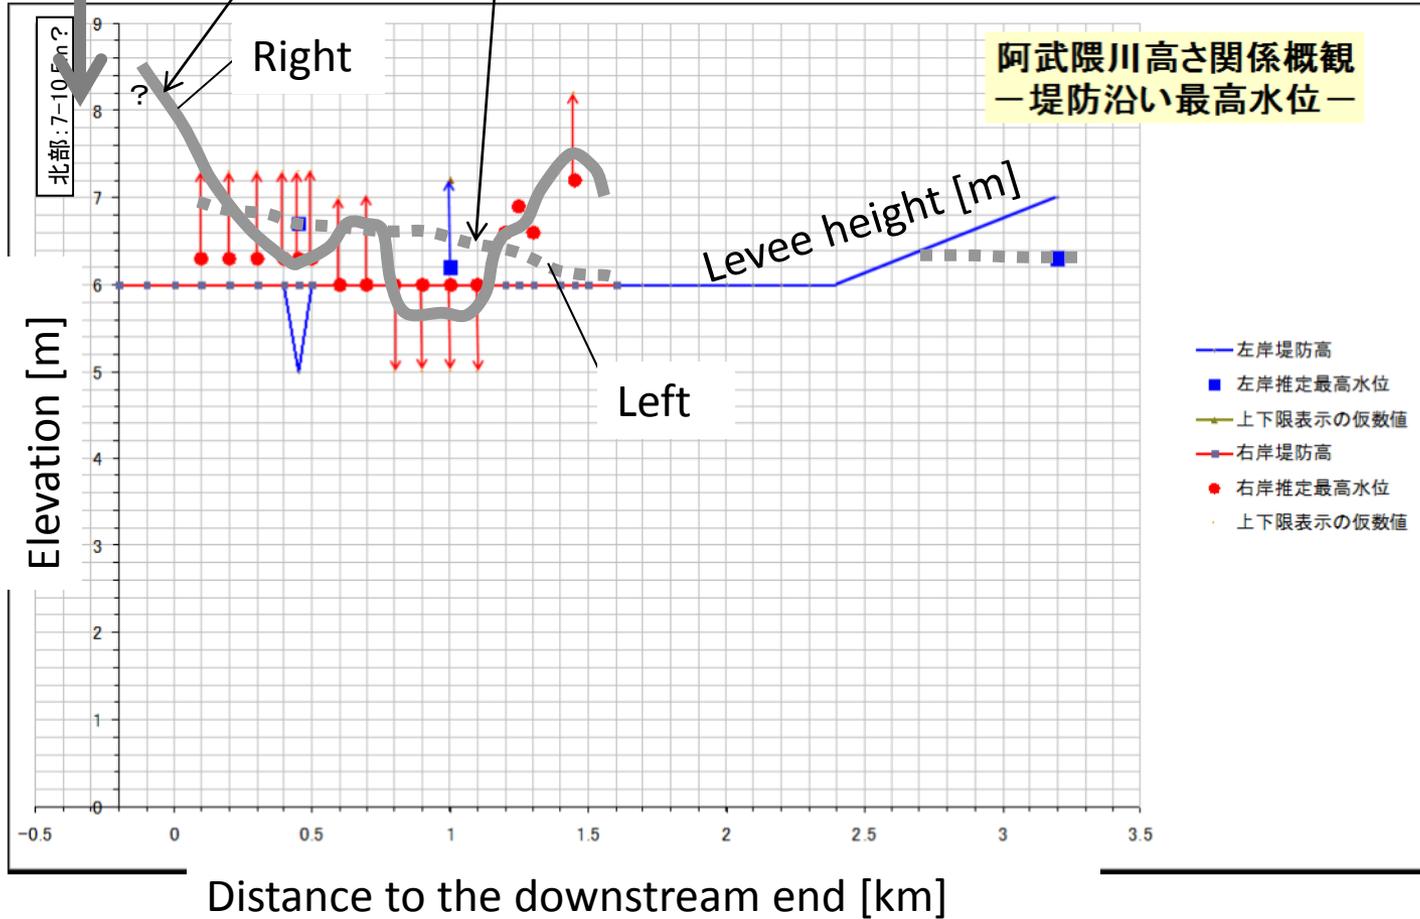
Possible longitudinal profiles of highest water levels along the Abukuma River

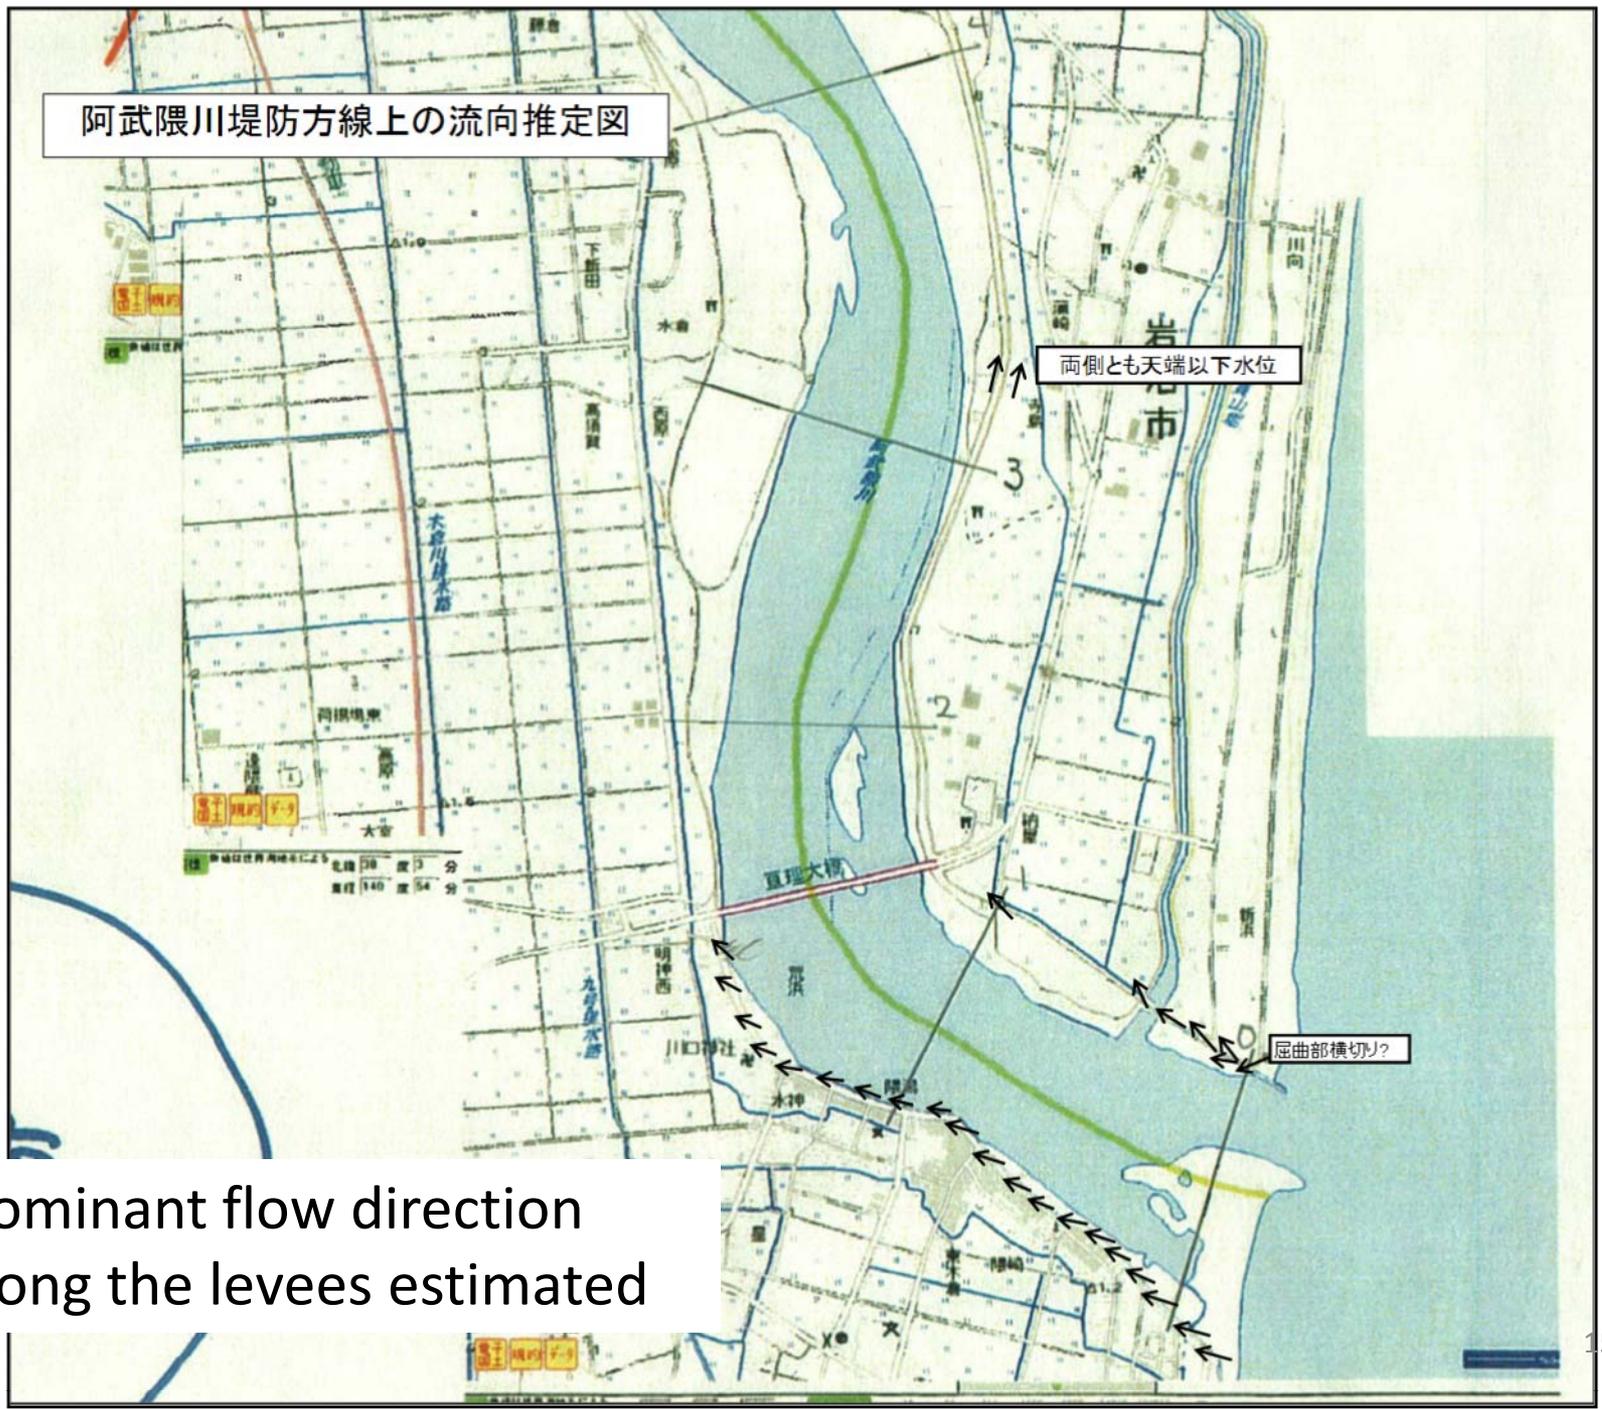
阿武隈川堤防方線上の流向推定図

Dominant flow direction along the levees estimated

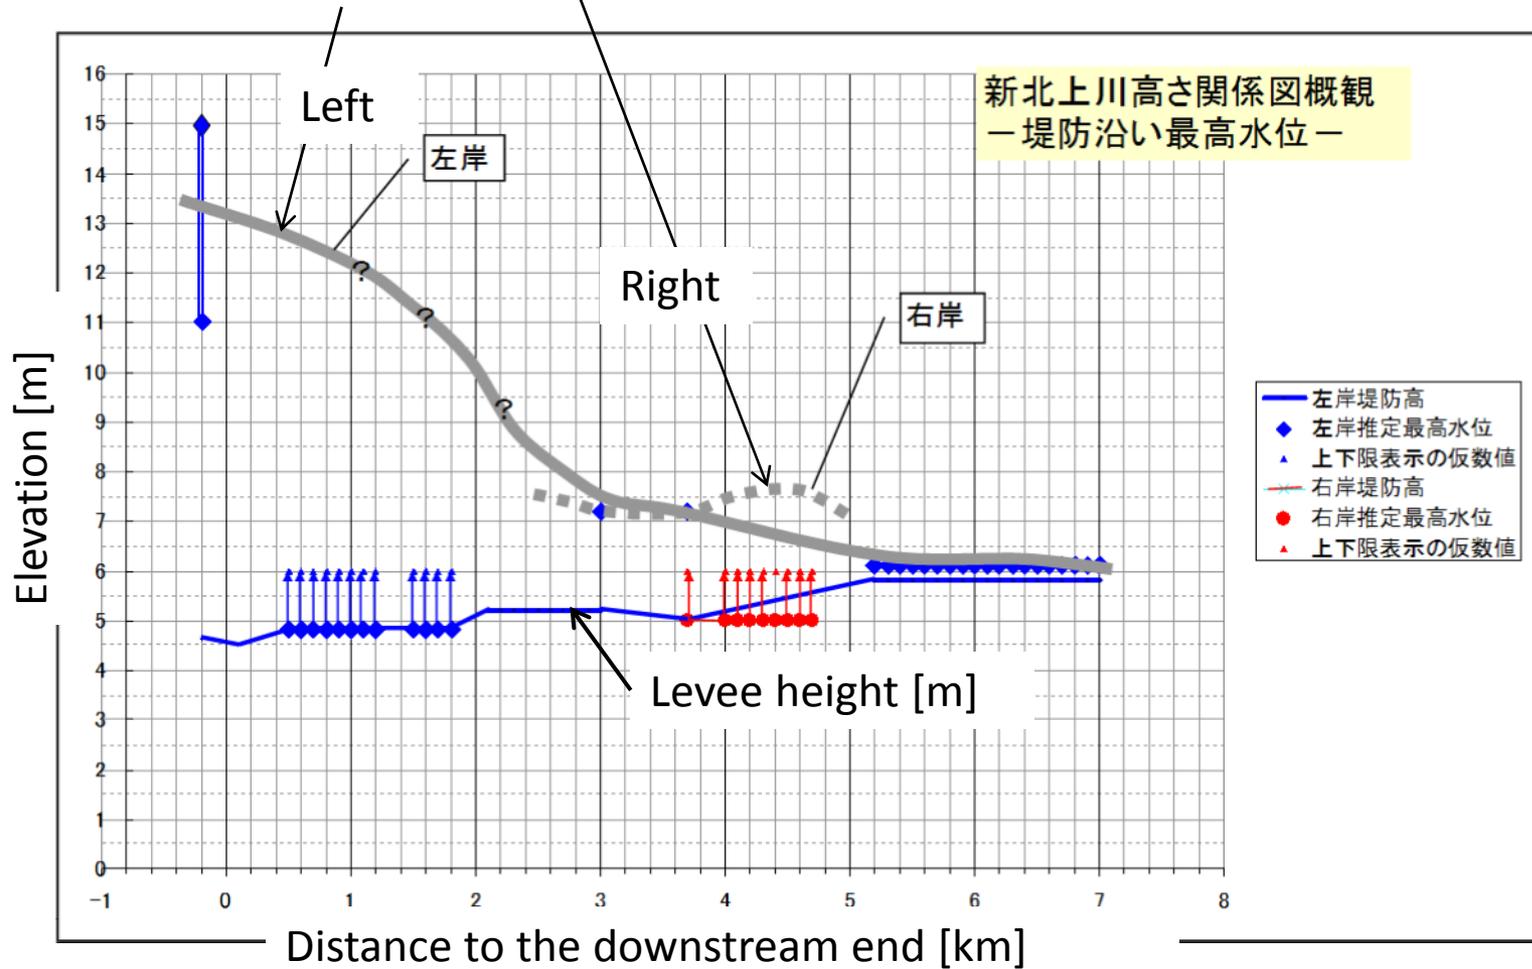
Possible longitudinal profiles of highest water levels along the New Kitakami River

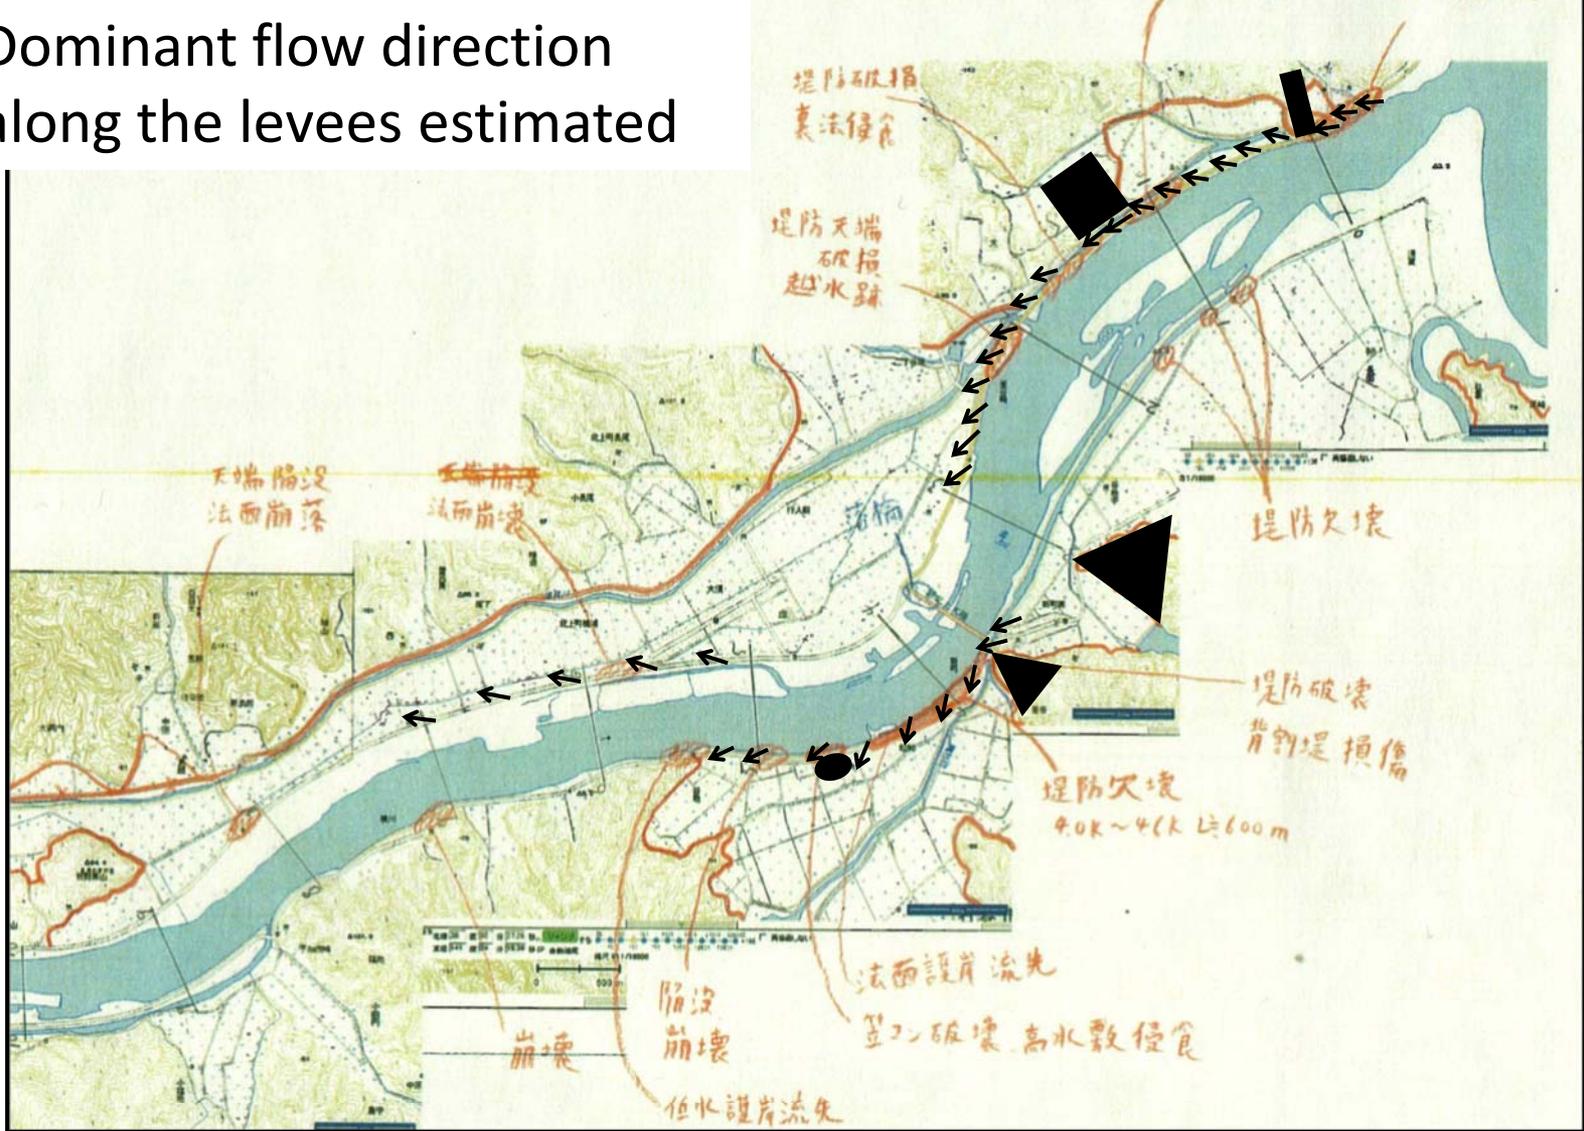
新北上川堤防法線上の流向推定図

Dominant flow direction along the levees estimated
